## Refurbishment of the Eroded Outlet Nozzle of a Recycled Gas Compressor Turbine Housing

# Pulsed Laser Beam Welding Leads the Race

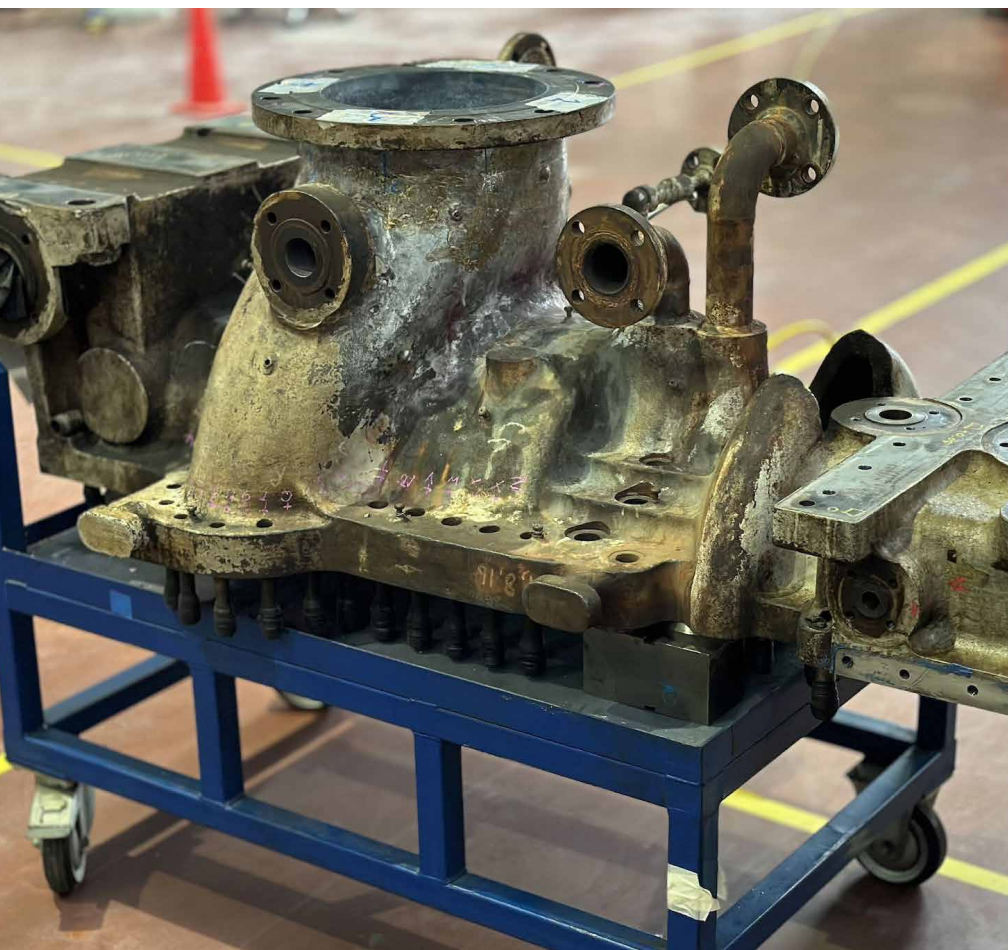
Fig. 1: Housing of the recycled gas compressor turbine (© DSI-Thailand)

The 4BL-5 recycled gas compressor turbine (Fig. 1) manufactured by Mitsubishi Heavy Industries is part of the core equipment of a company in the oil and gas industry based in Sri Racha on the east coast of the Gulf of Thailand. Technical data (Fig. 2) of the turbine:

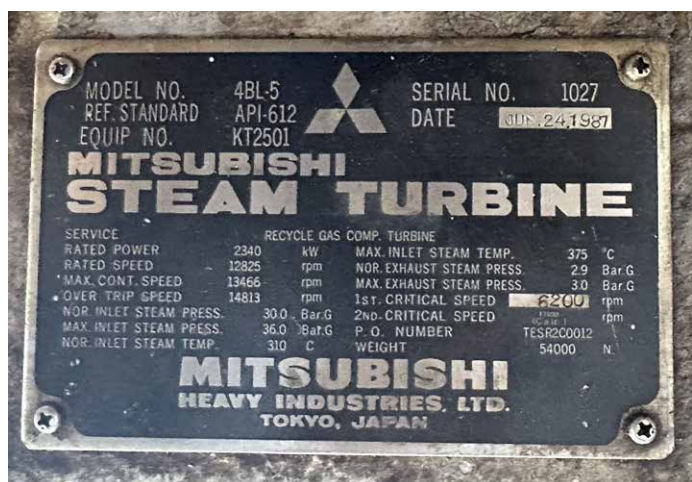
Fig. 2: Turbine nameplate (© DSI-Thailand)

- Year built 1987
- Base material A216 WCA (ASTM 216)
- Nominal power 2.340 kW
- Nominal speed 12,800 rpm
- Exhaust pressure 2.9 bar G
- •Max. operation temperature 375 °C.

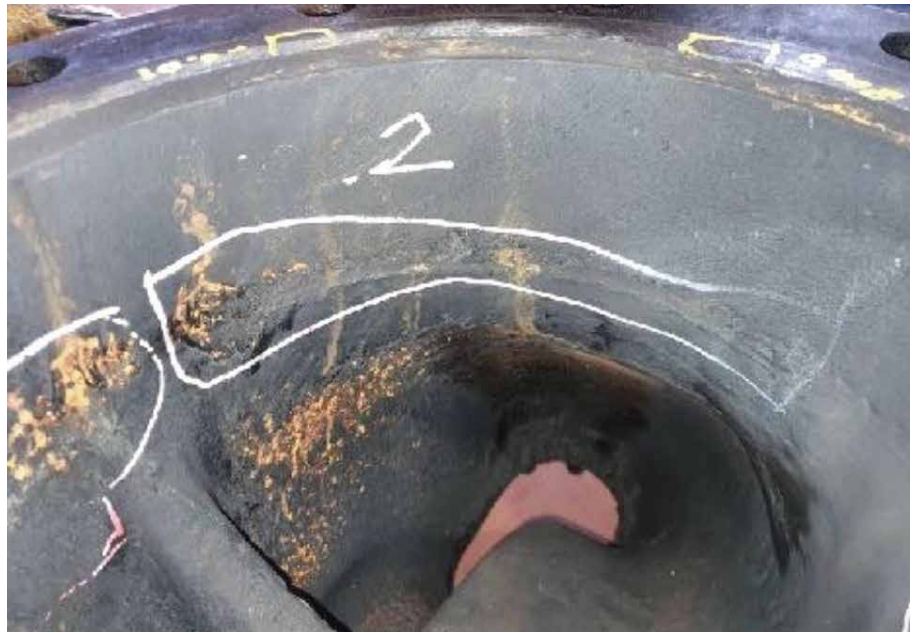
To avoid the worst-case scenario of an imminent plant shutdown, partial deposition welding was considered as a repair method, especially in the areas where erosion was most progressed. The wear profile in the selected repair areas (Fig. 3), based on an original wall thickness of 30 mm, was between a minimum erosion depth of 4 mm and a maximum of 11 mm.

Fig. 3: Part of the eroded areas in the gas outlet nozzle (© DSI-Thailand)

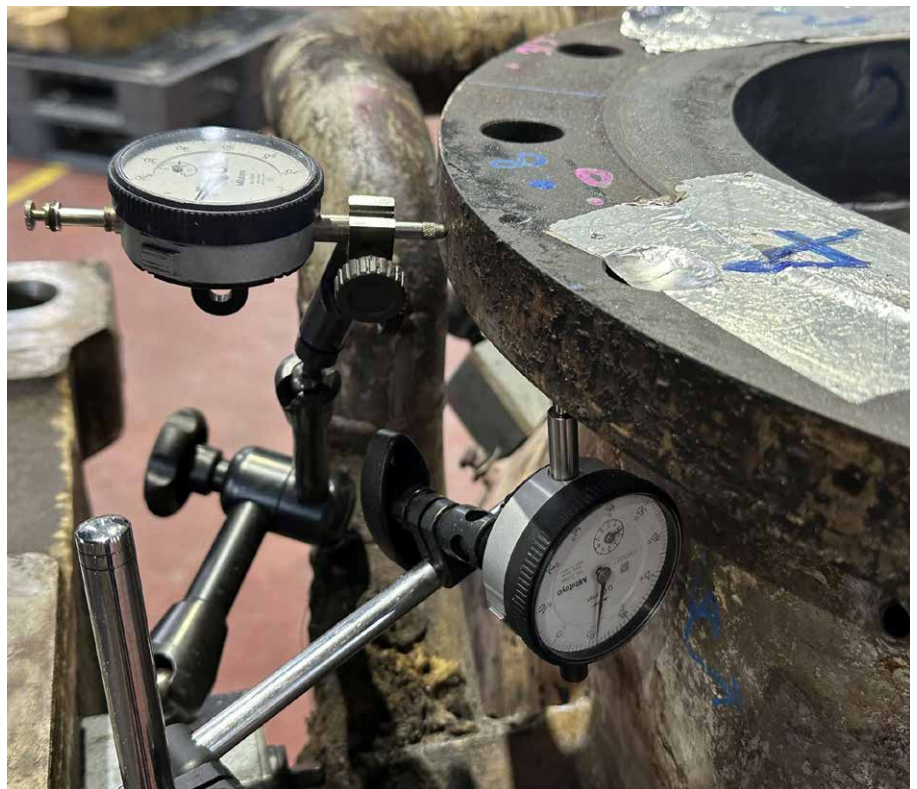
Fig. 4: Measuring setup for checking any welding distortion (© DSI-Thailand)

- Ultrasonic testing (UT) by third party (Fig. 9),
- Determination of the housing dimensions with regard to possible welding distortion (result: max. welding distortion = 0.025 mm)

- Determination of the actual housing dimensions, taking into account the shape and position tolerances, in particular the flanges and the reference surfaces.
- Preparation for pulsed laser beam welding: mechanical surface preparation of the intended welding areas by manual grinding.
- Setting up measuring devices (dial gauges) for continuous distortion monitoring during the ongoing pulsed laser beam welding process: A total of four dial gauges were installed around the turbine exhaust flange, each offset by 90° to each other, two dial gauges on the outer edge of the flange and two on the lower edge of the flange (Fig. 4).

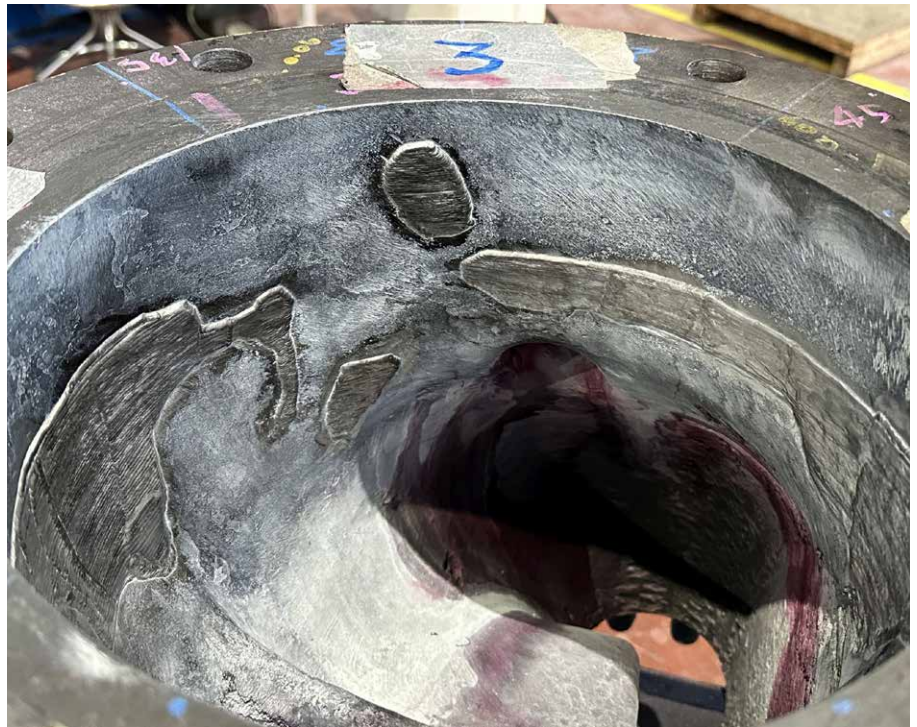
Fig. 5: Areas repaired by pulsed laser beam welding (© DSI-Thailand)

The deposit thickness to be welded was between 4 and 11 mm (Fig. 5). Taking into account the base material A216 WCA (ASTM 216), the filler material DSI M NICR625 (Inconel 625, material no. 2.4856), wire diameter 1.2 mm, was selected. Welding was carried out using an AL-Flak 1200 F fiber laser machine from the manufacturer Alpha Laser, whose welding direction movements were controlled by the operator using a joystick, while the filler material was fed in manually (Fig. 6). At 1,200 W pulsed laser power, the melting pool diameter was 4.8 mm.

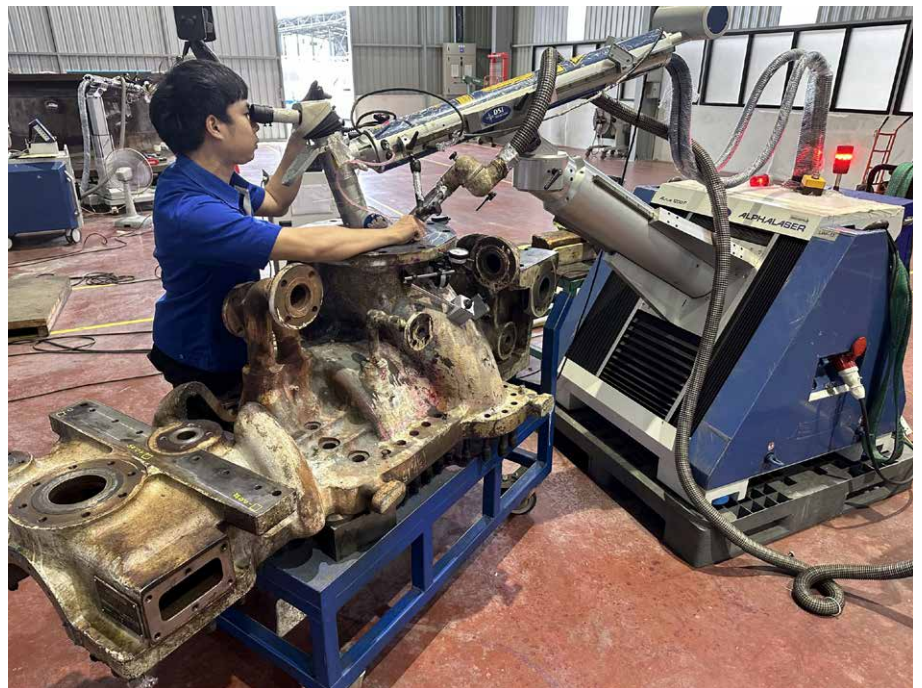
Fig. 6: Structure of component and fiber laser machine during pulsed laser beam welding (© DSI-Thailand)

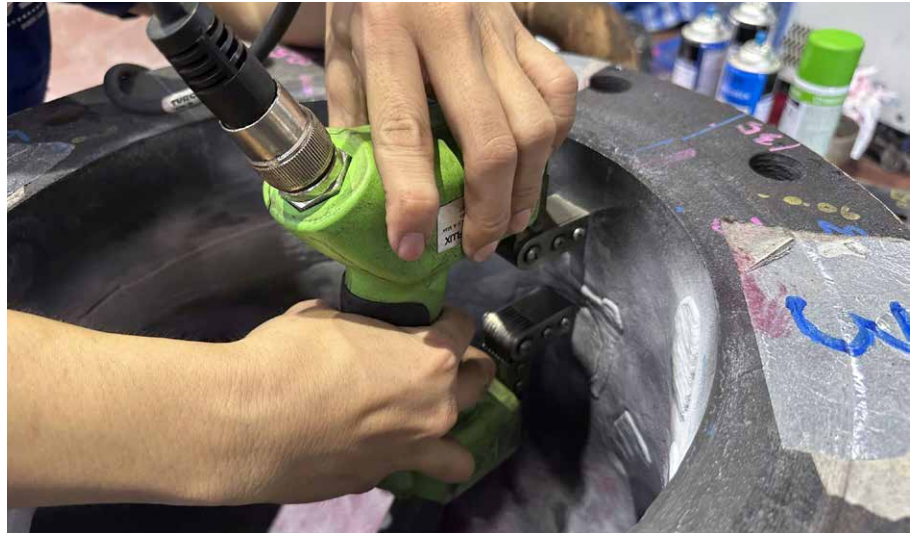
Fig. 7: Various methods were used for the final quality control, the picture shows the magnetic particle testing at the gas outlet nozzle (© DSI-Thailand)

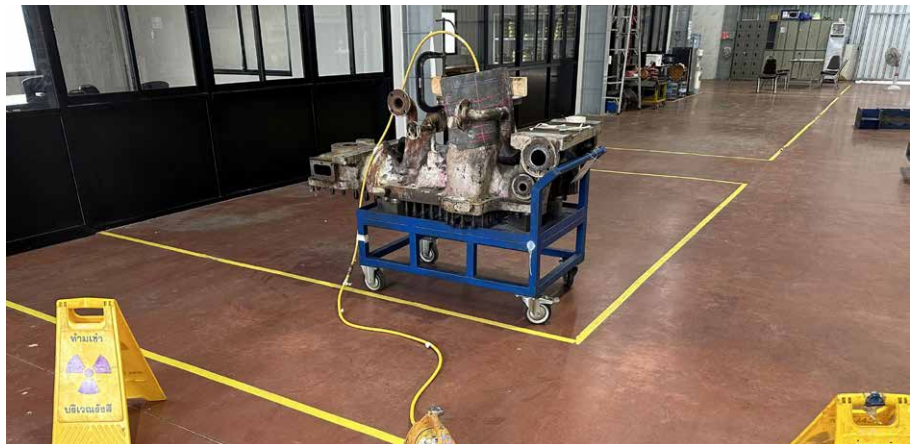
Fig. 8: Radiographic testing at the gas outlet nozzle (© DSI-Thailand)

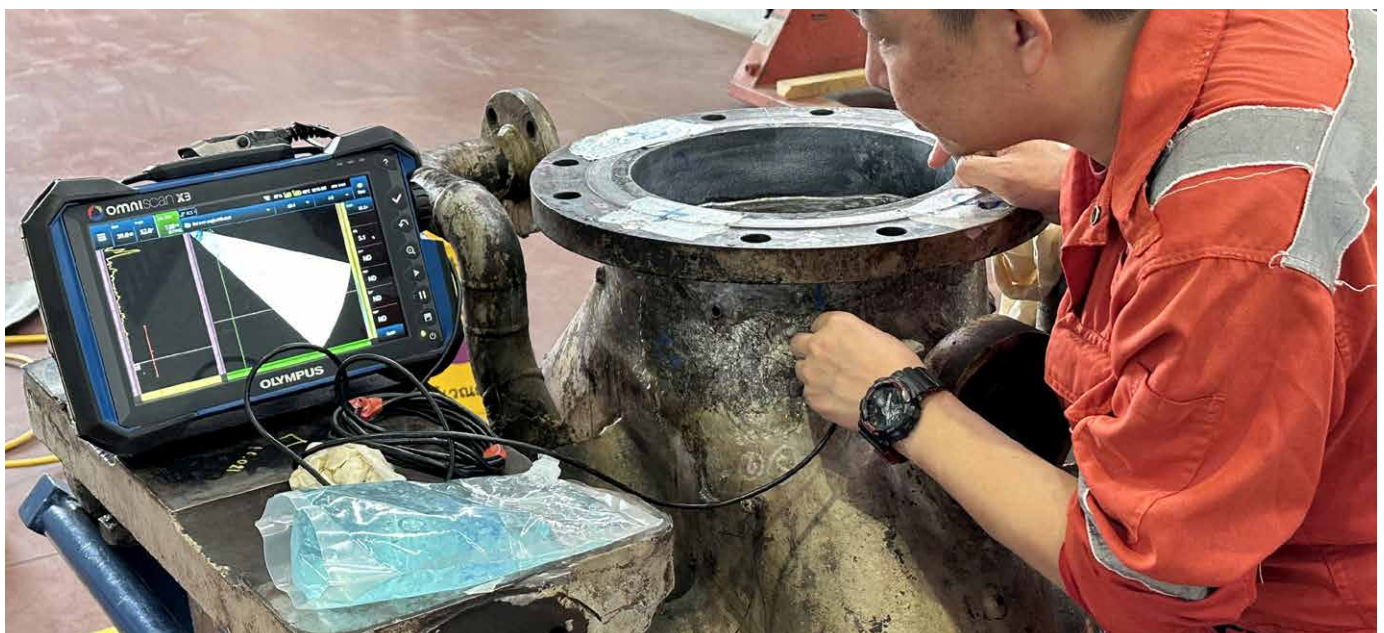
Fig. 9: Ultrasonic testing at the gas outlet nozzle (© DSI-Thailand)
