# Repair of a steam turbine in Thailand using pulsed laser beam welding

The rotor repaired by DSI (Thailand) (Fig. 1) is the rotor of a steam turbine built by Siemens in 2005. The 37 MW turbine is

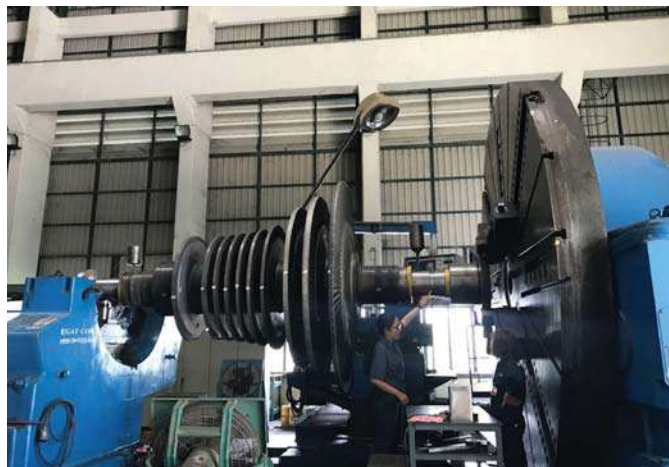
Fig. 1 • Placing the turbine rotor on the head lathe for mechanical pre-machining of the damaged surfaces.

The rotor of the turbine is oil-bearing. Due to a faulty operation during the operation of the turbine, a "deficient lubrication" occurred, i.e. an insufficient, "tearing off" lubricating film between the rotor shaft, which rotates at 3,000 revolutions per minute, and its mountings. The metallic friction and the resulting heat development caused cracks at both rotor shaft ends. After an initial damage assessment, cracks up to a depth of 2 mm were expected. Cracks up to a depth of 7 mm were found during the subsequent magnetic particle inspection (MT inspection) and during mechanical machining of the flaws on a head lathe.

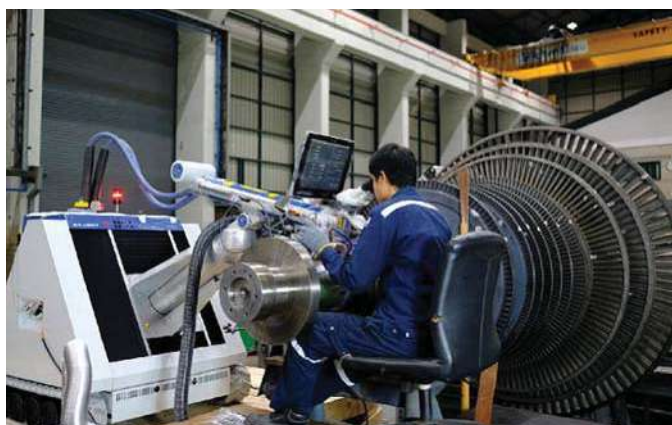
Fig. 2 • The Nd:YAG pulsed laser welding machine "900W ALFlak fibre" from the German manufacturer Alpha Laser in the welding application at the turbine rotor in Thailand.

EGAT, was used as welding filler. The laser used was a Nd:YAG pulsed laser welding machine (**Fig. 2**) with an average laser output power of 900 W. The wavelength was 1,059 nm. The welding was performed with a pulse frequency of 33.6 Hz, a pulse duration of 3.5 ms, a beam diameter of 2.5 mm and the shielding gas Ar 99.9%. A pWPS (pWPS-DSI-EGAT-Turbine-18.11.12) was available with all further necessary data. The DSI (Thailand) laser beam welders

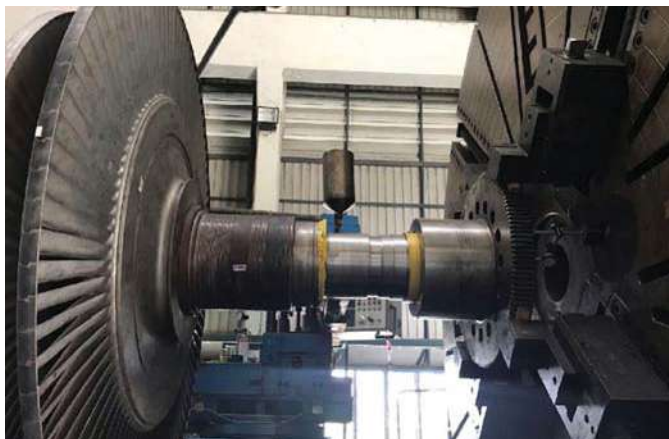
Fig. 3 • The turbine shaft mechanically prepared for welding.

After cleaning, the machining surfaces were machined to a depth of 2 mm in the crack area over a width of 332 or 340 mm and an additional 5 mm deep in the direct crack area over a width of 100 mm (Fig. 3).

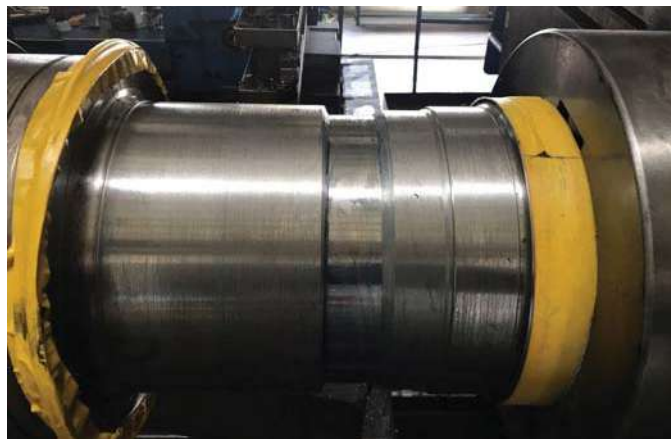
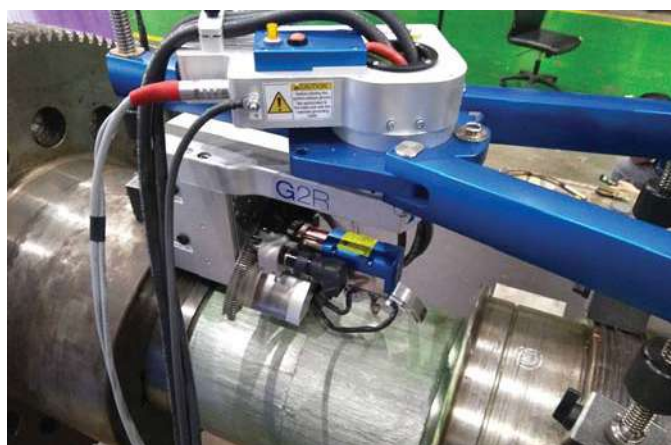
Fig. 4 • The measuring device installed before and during welding for stress testing of the turbine shaft.

In order to determine possible component stresses, a stress test was carried out using the "Residual Stress Measurement" method based on the "X-Ray-Diffraction" technique, in each case before, in intermediate steps during and after welding (Fig. 4). The welding on the turbine rotor on site in Thailand is shown in Fig. 5.

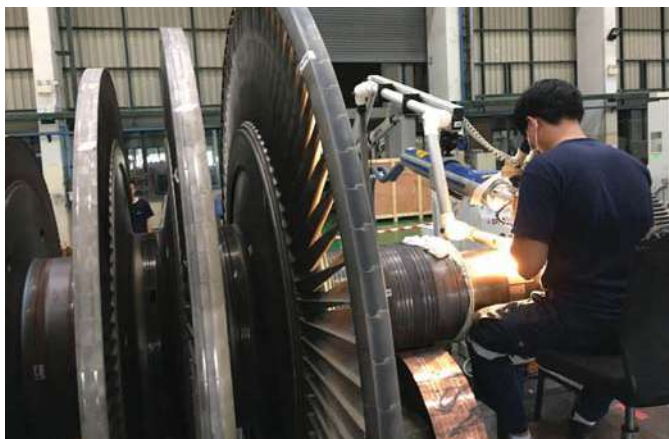
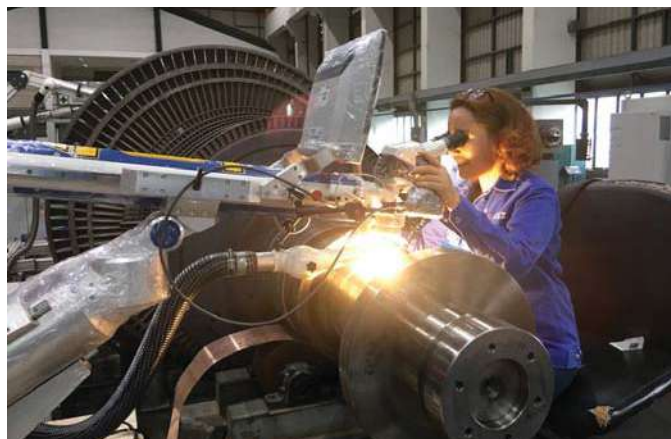
Fig. 5 • On-site welding on the turbine rotor.

The thickness of the seam applied in each layer was about 1 mm. In the direct crack area of the shaft (100 mm wide) there were approx. five to six circumferential layers, on the surface (332 or 340 mm) there were three layers.

From an economic/temporal point of view, this wide-area and large-volume repair welding was only possible by using two 900 W fibre lasers, which were used to weld simultaneously at both shaft ends. An interlayer result is shown in

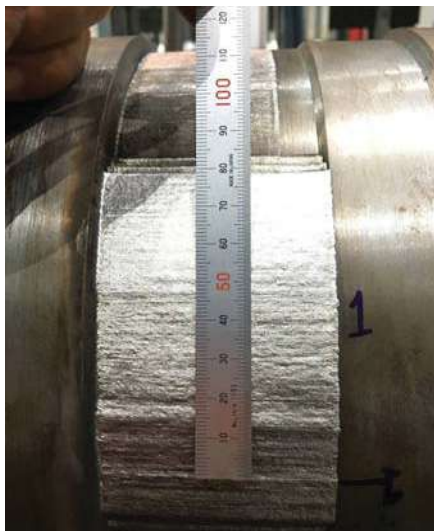
Fig. 6 • Layer structure of the pulsed laser beam repair welding.

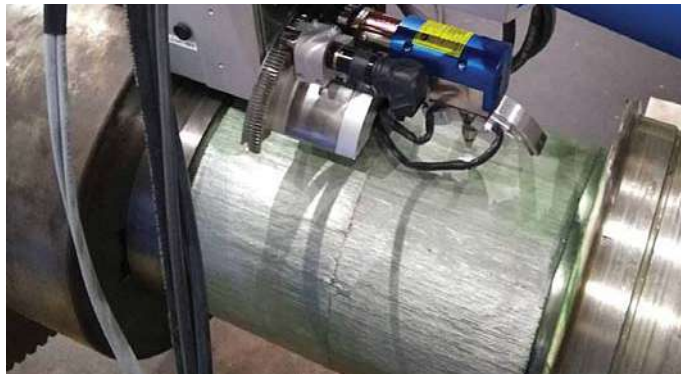
Fig. 7 • The finished pulsed laser beam weld during the final stress check.

Fig. 6. In addition to the final stress tests and visual inspections (VT), the finished welds (Fig. 7) were also tested by means of dye penetrant testing (PT), magnetic particle testing (MT) and ultrasonic testing (UT). After the successful tests, the welded surfaces at the rotor shaft ends were machined on a head lathe to the original dimensions and tolerances determined for their use.
