# Repair of a steam turbine in Thailand using pulsed laser beam welding

The rotor repaired by DSI (Thailand) (Fig. 1) is the rotor of a steam turbine built by Siemens in 2005. The 37 MW turbine is

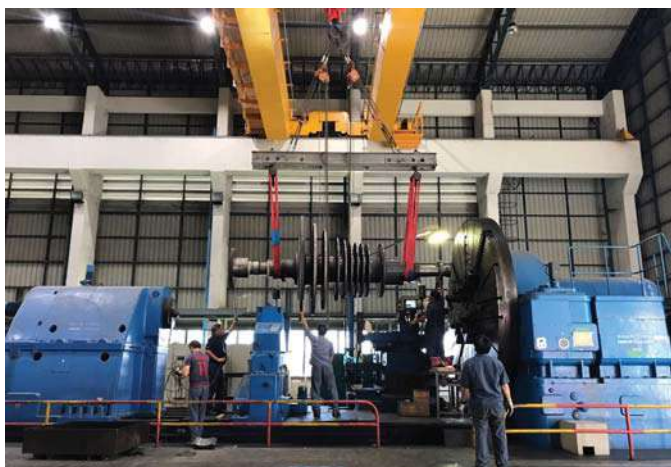
Fig. 1 • Placing the turbine rotor on the head lathe for mechanical pre-machining of the damaged surfaces.

The rotor of the turbine is oil-bearing. Due to a faulty operation during the operation of the turbine, a "deficient lubrication" occurred, i.e. an insufficient, "tearing off" lubricating film between the rotor shaft, which rotates at 3,000 revolutions per minute, and its mountings. The metallic friction and the resulting heat development caused cracks at both rotor shaft ends. After an initial damage assessment, cracks up to a depth of 2 mm were expected. Cracks up to a depth of 7 mm were found during the subsequent magnetic particle inspection (MT inspection) and during mechanical machining of the flaws on a head lathe.

After cleaning, the machining surfaces were machined to a depth of 2 mm in the crack area over a width of 332 or 340 mm and an additional 5 mm deep in the direct crack area over a width of 100 mm (Fig. 3).

The thickness of the seam applied in each layer was about 1 mm. In the direct crack area of the shaft (100 mm wide) there were approx. five to six circumferential layers, on the surface (332 or 340 mm) there were three layers.

From an economic/temporal point of view, this wide-area and large-volume repair welding was only possible by using two 900 W fibre lasers, which were used to weld simultaneously at both shaft ends. An interlayer result is shown in
